## KAMERA DO VOZIDLA FMC AMOS

ORL0198700

Kamera na pravú vidlicu, 51 °, jasná LED

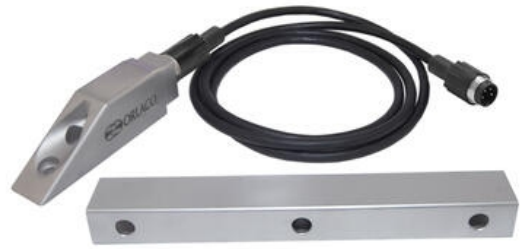
- K dispozícii s alebo bez LED svetidiel
- 12 V DC
- IP69K
- Odolný proti nárazom a vibráciám
- Nový kamerový senzor AMOS

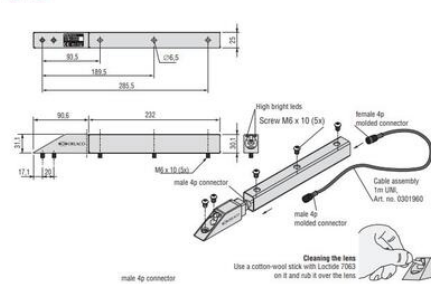
#### Dimensions

Front Side Molded Female connector

#### Electrical connection

Art. No 0301960 Cable 1m UNI

1 = Coax core = Video Signal  
2 = Coax Shielding = Video GND  
3 = Red = 12V/DC  
4 = Black = 0V/DC  
Shielding = N.C.

Front Side Molded Male connector

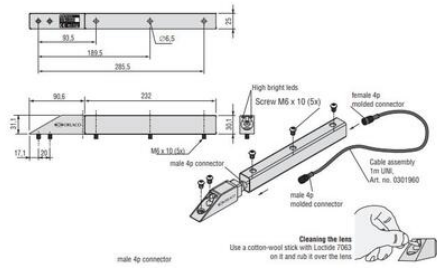
**Dimensions**

Front Side Molded Female connector

#### Electrical connection

Art. No 0301960 Cable 1m UNI

1 = Coax core = Video Signal  
2 = Coax Shielding = Video GND  
3 = Red = 12V/DC  
4 = Black = 0V/DC  
Shielding = N.C.

Front Side Molded Male connector
