KAMERA DO VOZIDLA FMC AMOS

ORL0198700

Kamera na pravú vidlicu, 51 °, jasná LED

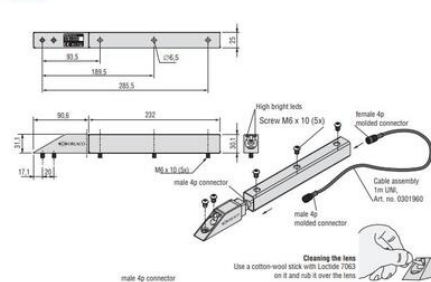
Front Side Molded
Male connector**Dimensions**

Front Side Molded
Female connector**Electrical connection****Art. No 0301960 Cable 1m UNI**

1 = Coax core = Video Signal
2 = Coax Shielding = Video GND
3 = Red = 12V/DC
4 = Black = 0V
Shielding = N.C.

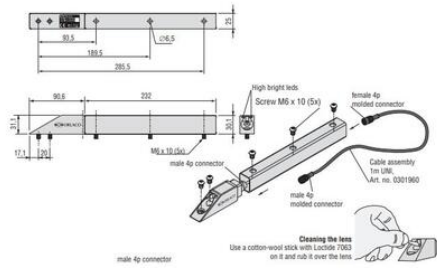
Dimensions

Front Side Molded
Female connector**Electrical connection****Art. No 0301960 Cable 1m UNI**

1 = Coax core = Video Signal
2 = Coax Shielding = Video GND
3 = Red = 12V/DC
4 = Black = 0V
Shielding = N.C.

Front Side Molded
Male connector
